# **Spot Safety Project Evaluation**

Spot Safety Project # 09-98-211

**Spot Safety Project Evaluation of guardrail installation at overhead sign support on I 40 (0.9 mile east of NC 109) in Forsyth County**

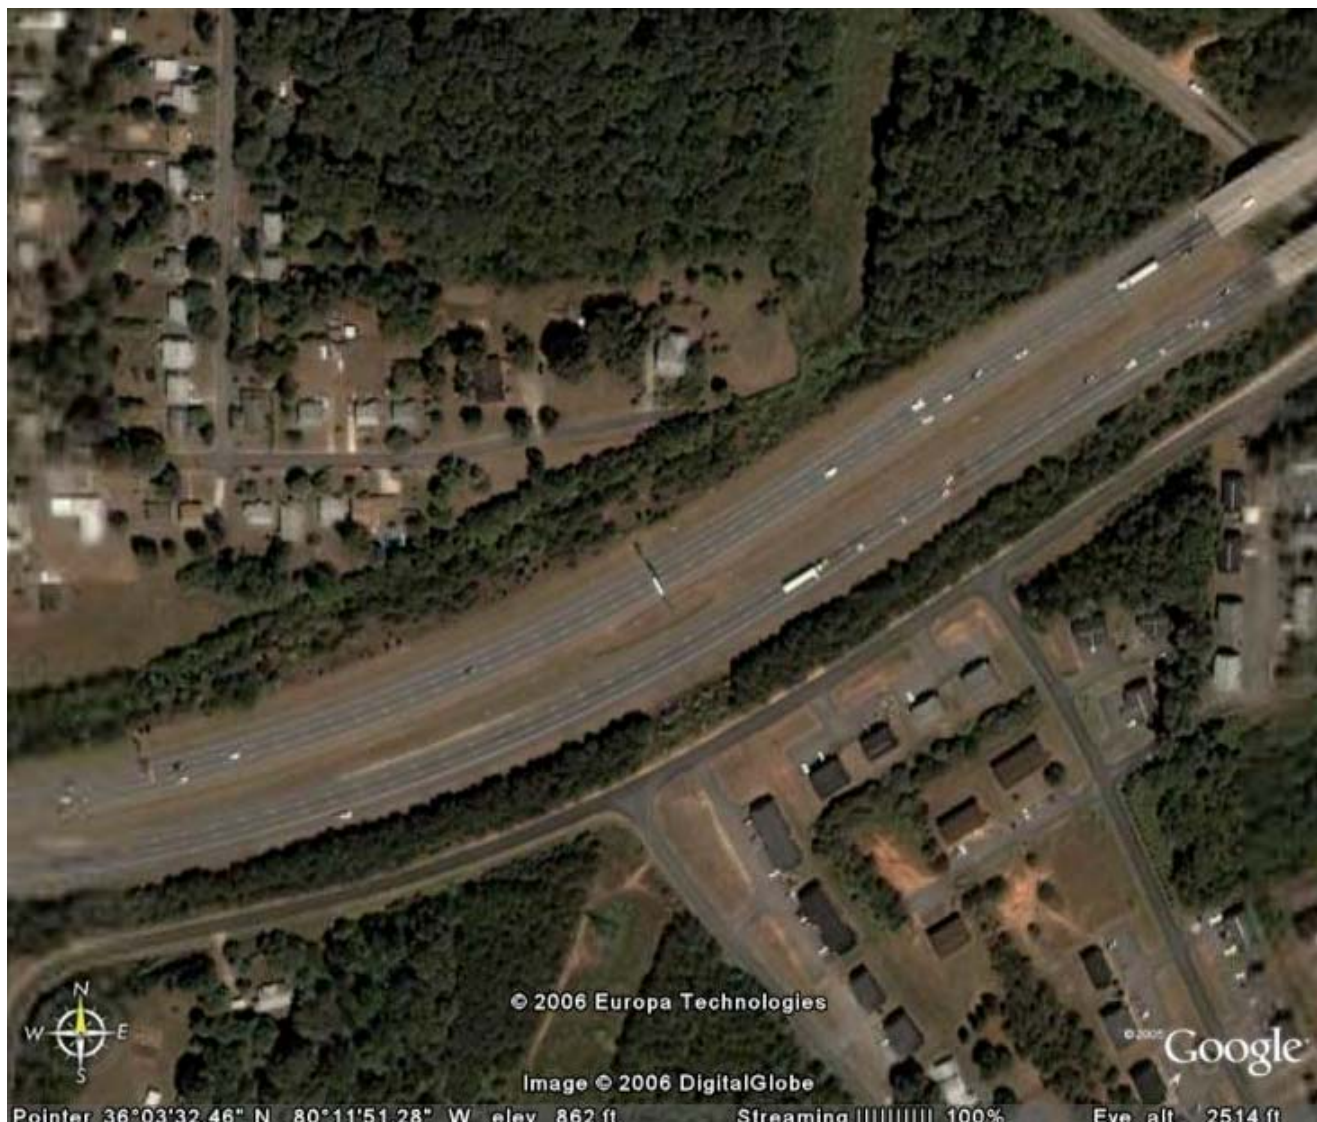
*Treatment Site Photos taken November 14, 2005*  
Facing West

The photos from the field visit show that there was a potential for vehicles to travel through the gaps between the median barrier and the sign support. The guardrail installation may reduce this potential and lower the possibility of a cross-median crash due to its length and placement.

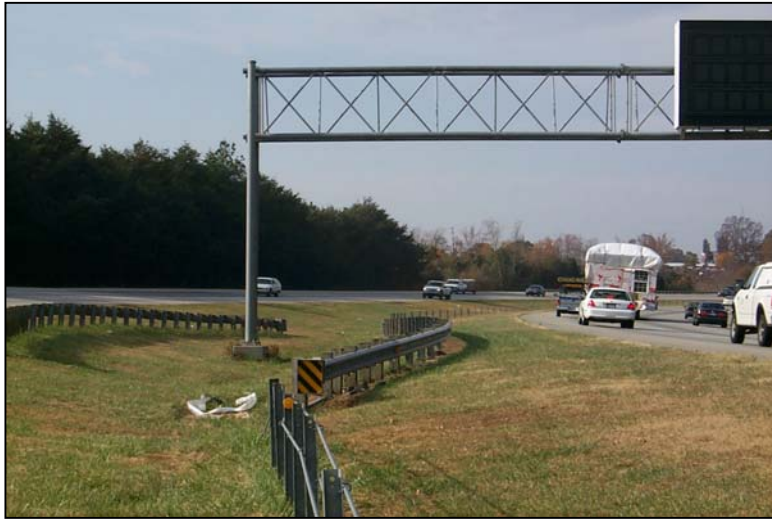
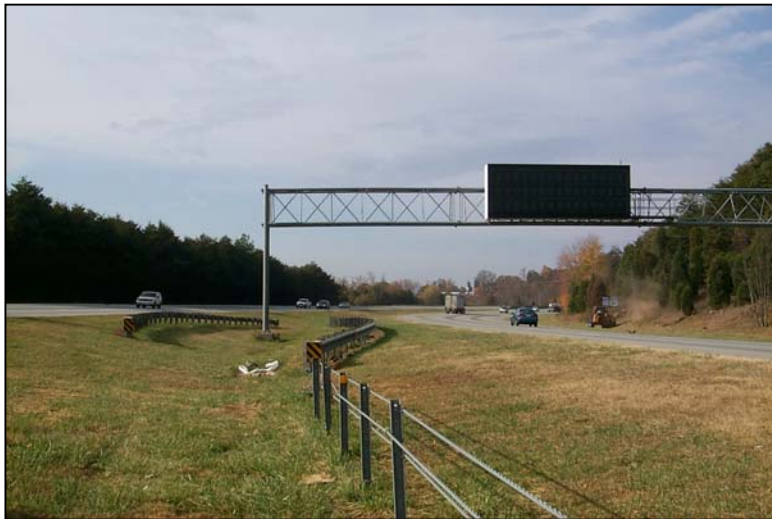
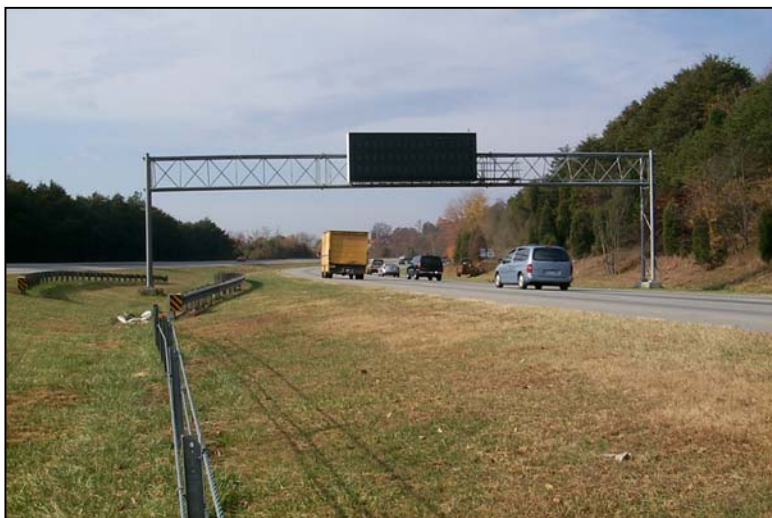
Referencing the photos, the guardrail was placed around the sign support in the median. It seems the guardrail installation may perform its intended function of reducing the severity of a crash at this location. However, information from the crash reports show two out of the three total crashes with the overhead message board were along the right shoulder in the westbound lanes resulting in class B and C injuries. Protection for this sign support may also need to be evaluated.
